OPERATION CROSSROADS

BUREAU OF SHIPS INSTRUMENTATION GROUP

Displacements of
Shock Mounted Equipment

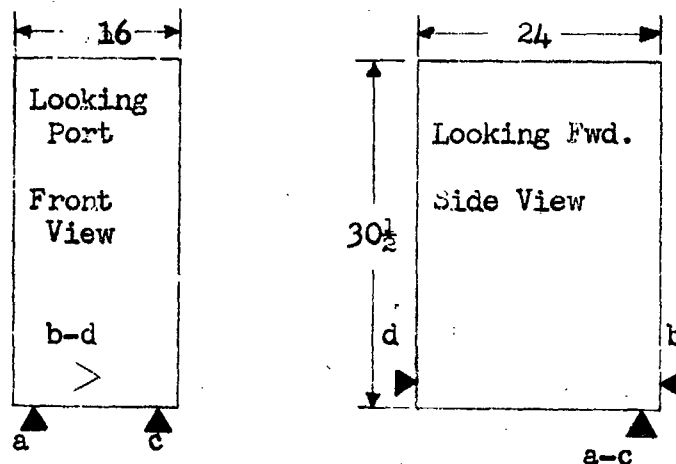
DD389 #1 Gages:

Location: On Radio Transmitter Model TDQ, in Radio Transmitter Room, First Superstructure Deck. The transmitter is in the port side of the room.

Type of Mounting: Short C type mounts on each bottom corner.

Able: The starboard side of the transmitter room was pushed in about 3 inches. In spite of the bottoming of the mounts and the collisions of the unit with the angle iron framing, the TDQ appeared to be in good condition and to key properly. A near by transmitter.

properly. A near by transmitter model TBK had a tube broken and did not key properly.
Baker: No data was obtained for this unit.

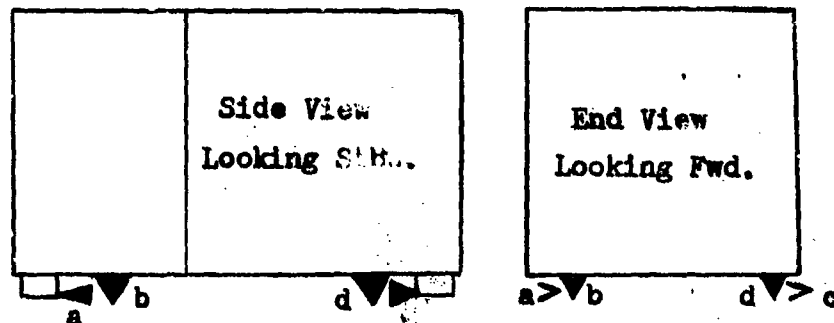
DD408 #8 Gages:

Location: On Emergency Diesel Generator, in Compartment A-206-E (frame 56, deck below main deck).

Type of Mounting: Rubber mounts in compression. Less than 1/8 inch clearance laterally.

The diesel generator was quite rigidly mounted. No knowledge was obtained of the detailed properties of its supports. No damage was suffered by the equipment.

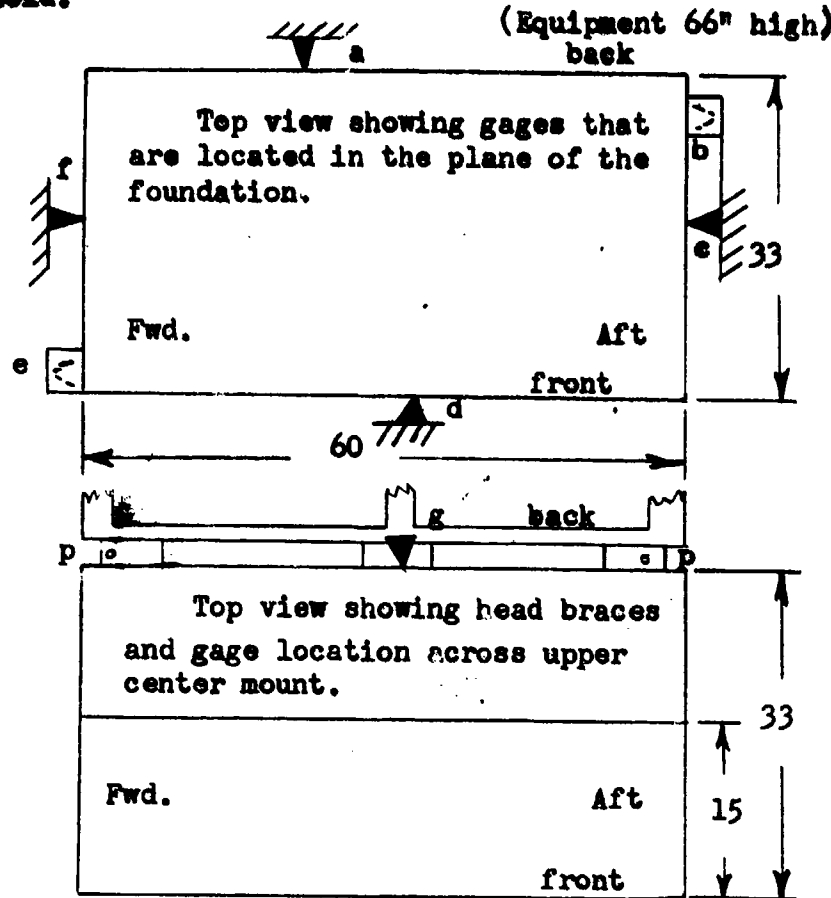
APA79 #1 Gages:

Location: On Control Bench (BuShips Section 660 Item 13E4) at Starboard Side, Second Platform Deck, in Forward Cargo Hold.

Type of Mounting: Special built-in mounts using rubber in compression.

Able: The hatch cover collapsed into this hold and the overhead was bent down over the switchboard. However there was no damage from other causes at the switchboard location or to the switchboard caused by the Able test.

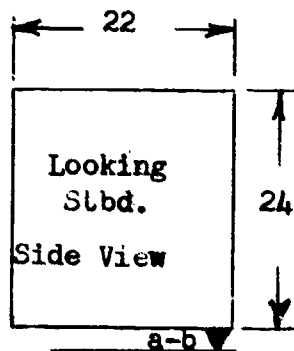
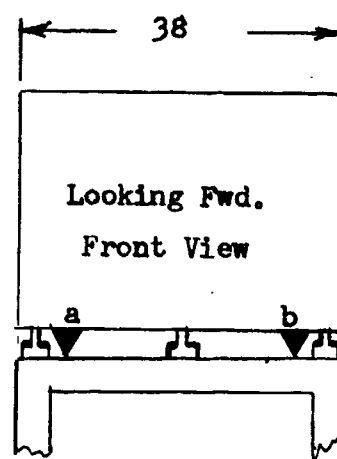
BB 34 #3 Gages:

Location: On Range and Train Indicator, type GNP-55 AFH, in Forward Port Corner of C.I.C. Room on Signal Bridge.

Type of Mounting: Three C type mounts run the full depth of the equipment as shown above. Vertical clearance of mounts is about 1/2 inch.

Baker: It is probable that the apparatus bottomed, but with little excess energy. If it is assumed, as a reasonable approximation, that the frequency of vertical vibration is 10 cps, then at least 1/2 inch clearance is required. This is about 5 times the static deflection. The equipment was not obviously damaged.

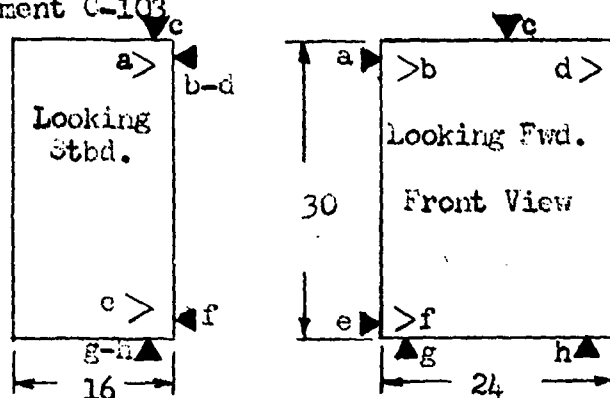
BB34 #5 Gages:

Location: On Radio Transmitter Model TD₄, in Forward Starboard Corner of Radio Transmitter Room, on the Third Deck, Compartment C-103.

Type of Mounting: Short C type mounts at bottom corners. Clearance to bottom mount is 1/2 inch. The unit is mounted in an angle iron frame.

Baker: No shock mounted apparatus in this compartment appeared damaged although there was a considerable quantity of equipment, as fans, starting boxes, etc., broken loose from the bulkheads. It is evident that the damaging components of shock involved such small displacements that the clearances of about 1/2 inch provided sufficient protection with the type of mounts used.

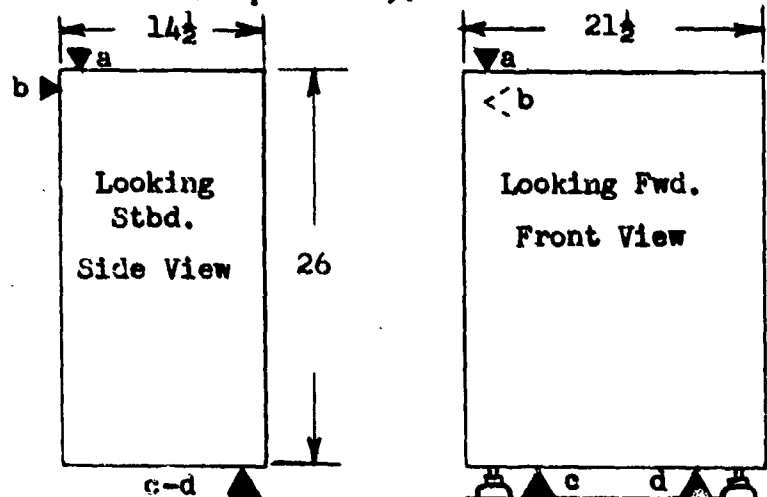
CA24 #2 Gages:

Location: On High Voltage Rectifier type CW-20280, a Unit of Mark 28 Radar; in Radar Transmitter Room (just above the communication platform).

Type of Mounting: L type mounts on four bottom corners. Clearance to shoulder of mount is about 1/16 inch, however the shoulder is one inch thick.

Gage CA24 #2	a	b	c	d
Able	0.30	0.56	0.42	0.42
Baker	Room too damaged to obtain readings.

Baker: The compartment was severely damaged and was filled with a chaotic mass of loose material.

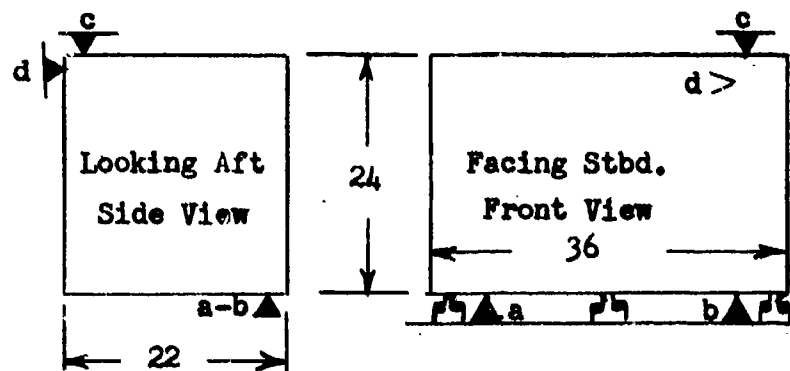
CA25 #4 Gages:

Type of Mounting: Three C type mounts, spaced as shown above, extend the full depth of equipment. Vertical clearance of 5/16 inches.

Able: The shock was greater in the downward than in the upward direction, however it was minor in nature. There was extensive damage just aft of the C.I.C. room, but none apparent in C.I.C.

Baker: A shock of considerable intensity in the vertical direction caused the mounts to bottom. There was no apparent damage.

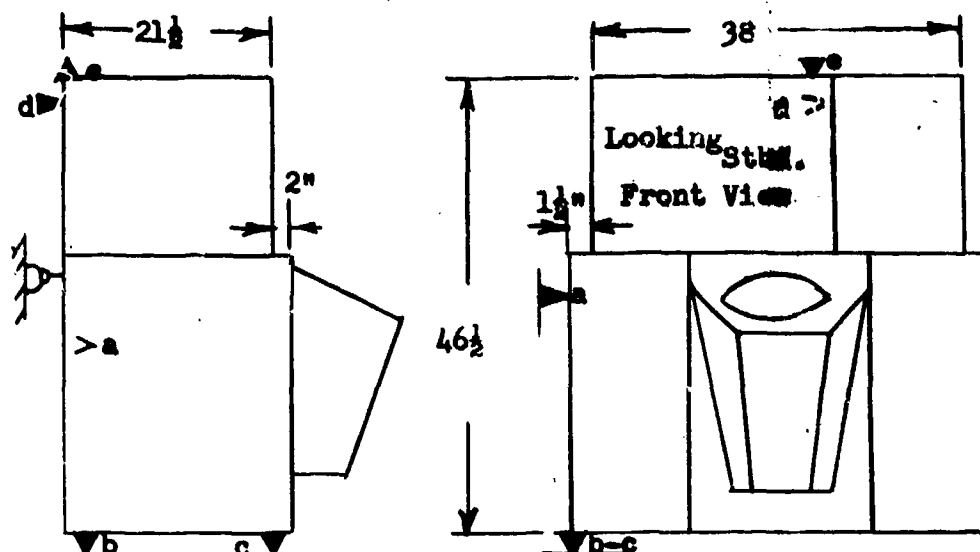
CA25 #5 Gages:

Type of Mounting: Short C type mounts at each bottom corner.
L type mounts on upper back corner of main unit. Vertical
clearance is about 1/8 inch.

Able: The shock mounts bottomed hard and there was considerable displacement after bottoming due to the bending of the cabinet parts. However, because of the softness of the mounts it is not probable that the shock was severe. There was no apparent damage to the unit.

Baker: The vertical displacements indicate considerable shock in that direction. There was no apparent damage to the unit.

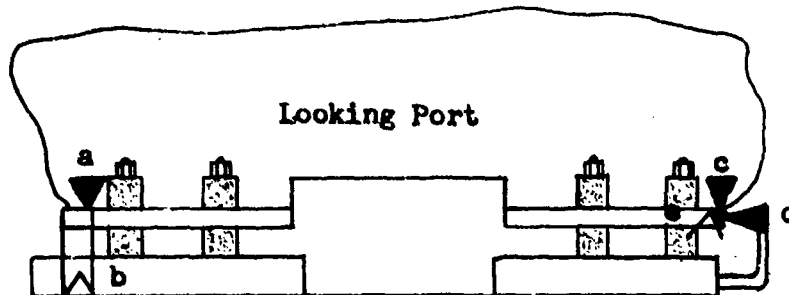
SS184 #1 Gages:

Type of Mounting: Mounts are as shown on each of the four bottom corners of the M-G set. The rubber is about 1 1/4 inches thick.

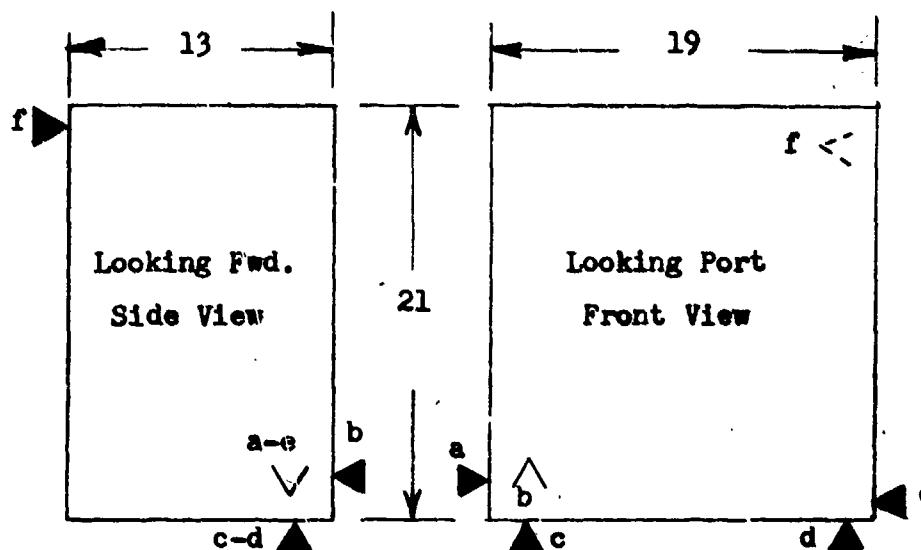
SS335 #4 Gages:

Type of Mounting: L type mounts on four bottom corners and on two upper back corners. Clearance of mounts is about 1/4 inch to their shoulders which are about 1 inch thick.

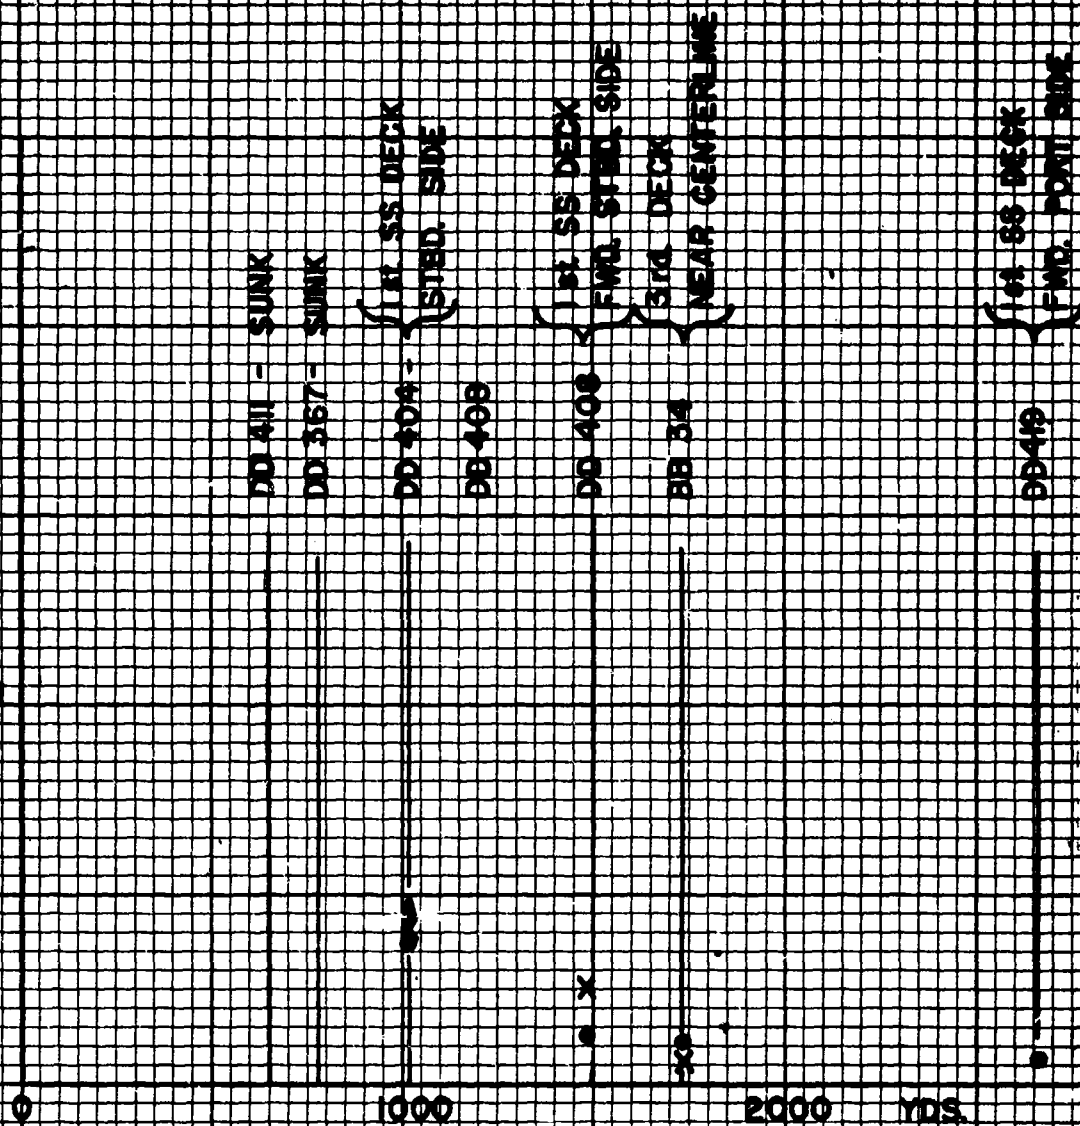
AN ARROW ATTACHED TO A POINT INDICATES BOTTOMING

DESTROYERS SEVERE TOP SIDE LITTLE DAMAGE
SUNK ——— DAMAGE ———

NATURAL FREQ. OF RRO ON ITS MOUNTS;
VERTICAL TRANSLATION - 12 CPS; ROCKING - 9 CPS (BOTH LOWER MODES)

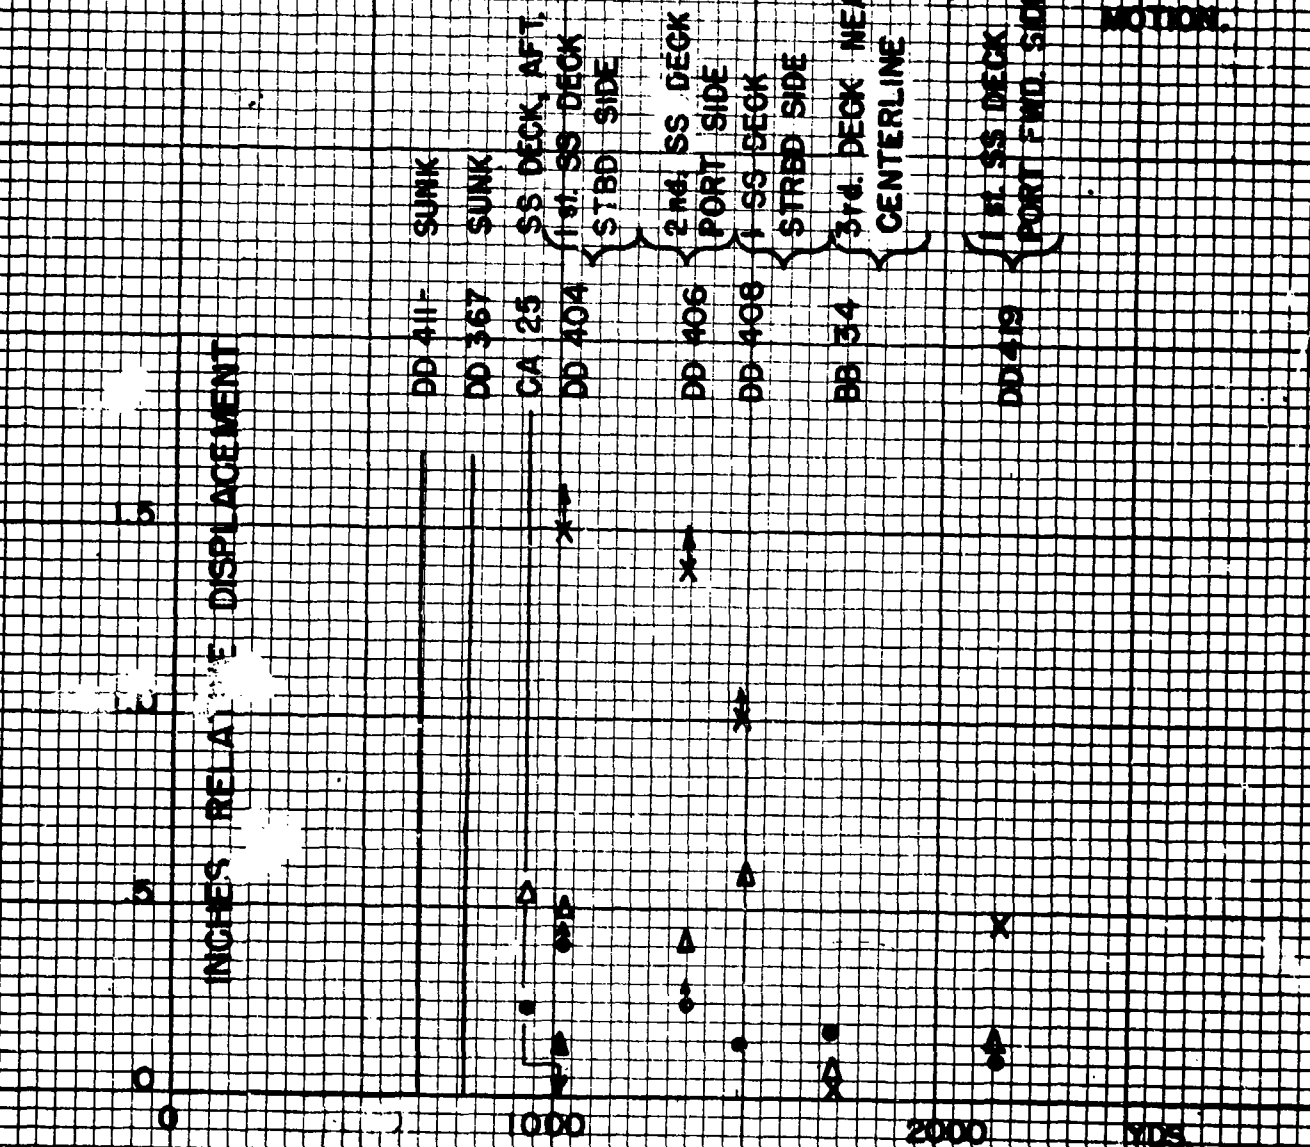
▲ FORE & AFT, BOTTOM OF UNIT
AN ARROW ATTACHED TO A POINT
INDICATES THAT BOTTOMING PREVENTS
GREATER
MOTION.

DESTROYERS ← SEVERE → LITTLE DAMAGE
SUNK TOP SIDE TO SHIPS
DAMAGE

NATURAL FREQ. OF TDQ ON ITS MOUNTS:

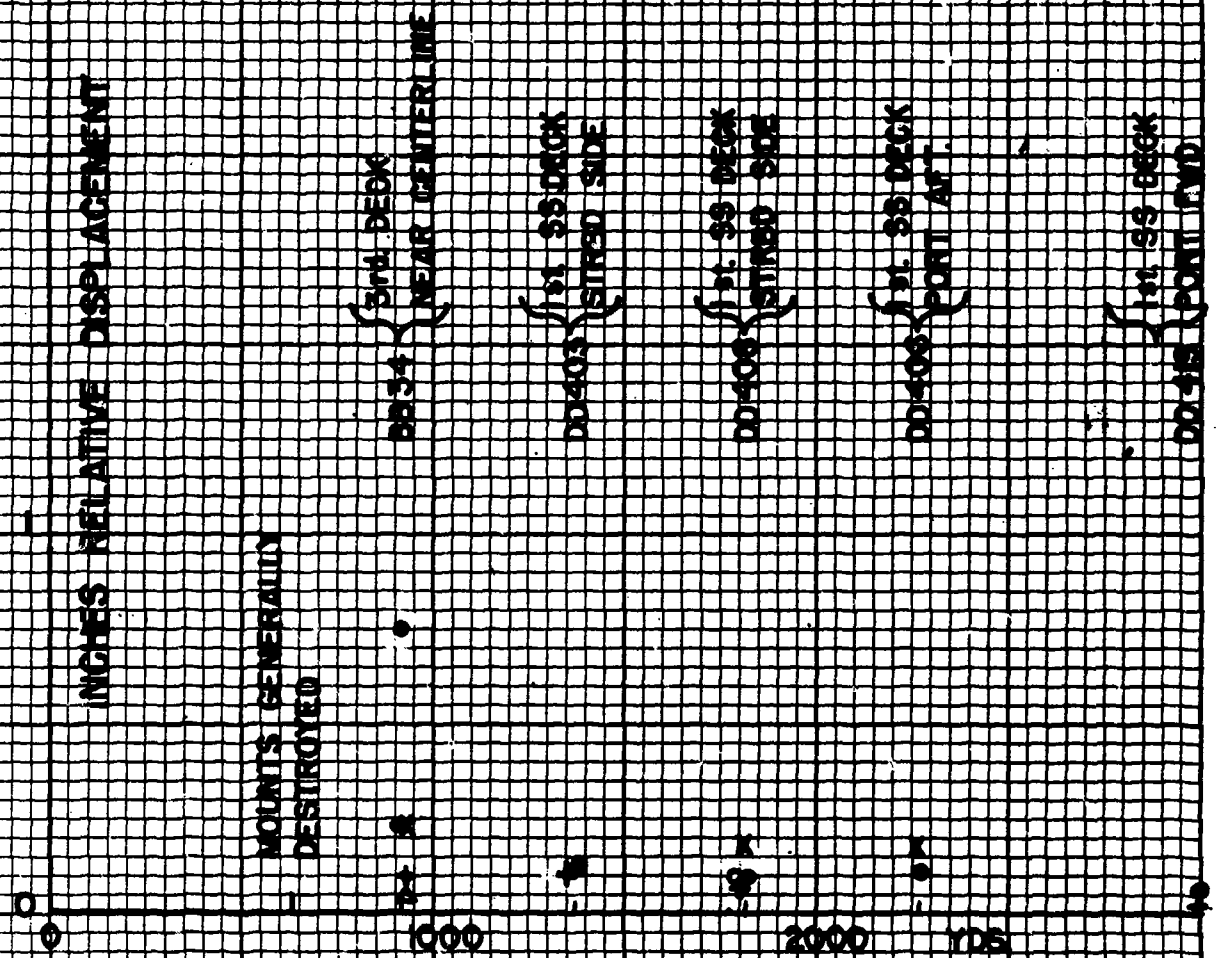
NATURAL FREQ.: VERTICAL 12 CPS (STATICS DEF. 0.07")
ROCKING - 8 TO 10 CPS
(BOTH LOWER MODES)
